**Coal Combustion Residue Impoundment  
Round 9 - Dam Assessment Report**

***Oklahoma Power Station***

***Wastewater Evaporation Pond 6 – WMU 001***  
***American Electric Power***  
**Vernon, Texas**

**January 2012**

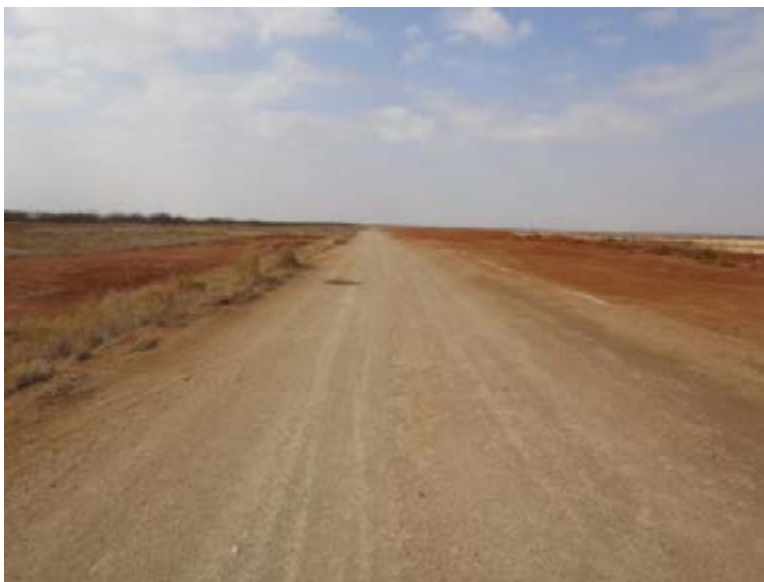
The crest of the South Embankment showed no signs of depressions, tension cracks, or other indications of settlement or shear failure, and appeared to be in satisfactory condition. Figure 5.2.1-1 shows the conditions of the crest of the South Embankment.

Figure 5.2.1-1. Figure showing the South Embankment crest and outside slope conditions.

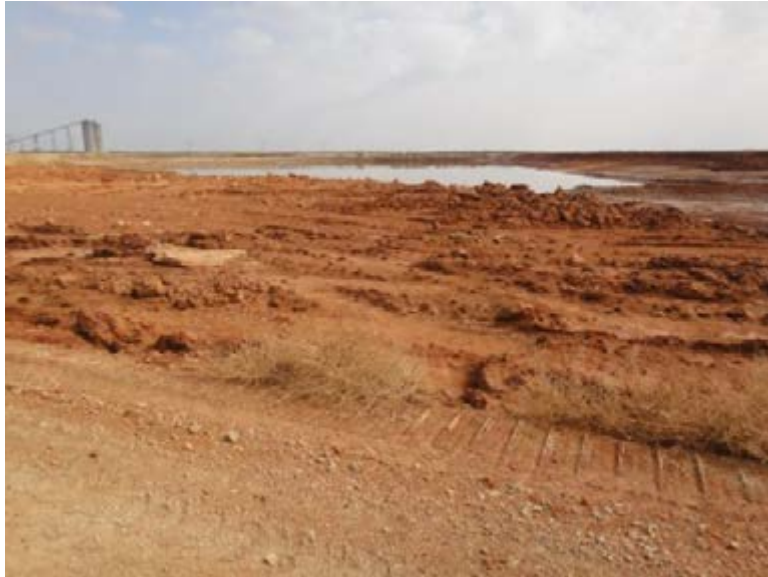
The South Embankment's inside slope has been filled up to the crest elevation with native soil, effectively eliminating this slope on the east end of the embankment. Figure 5.2.2-1 shows these areas.

Figure 5.2.2-1. Figure showing the South Embankment lack of inside slope.

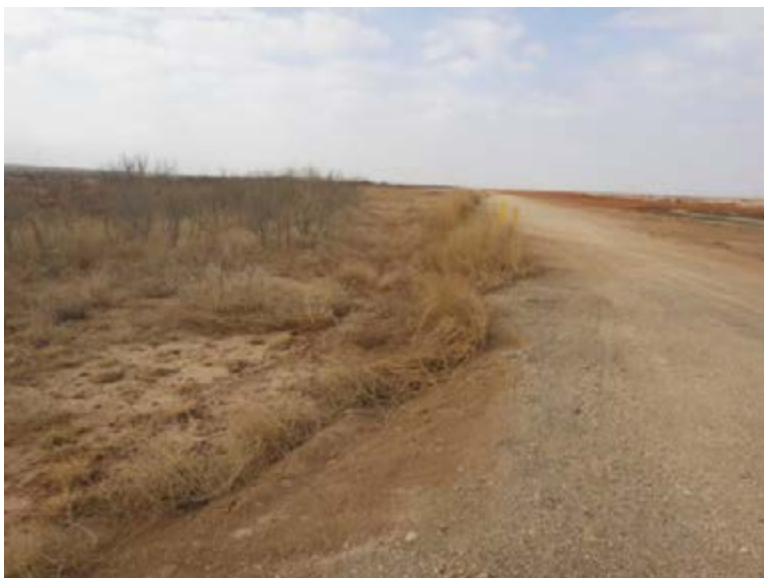
There were no observed scarps, sloughs, bulging, cracks, or depressions indicating slope instability or signs of erosion. The outside slope of the South Embankment was covered with sparse overgrown vegetation. The outside slope appears to be in good condition. Figure 5.2.3-1 shows the general condition of the outside slope of the South Embankment.

Figure 5.2.3-1 general good condition of the outside slope of the South Embankment.

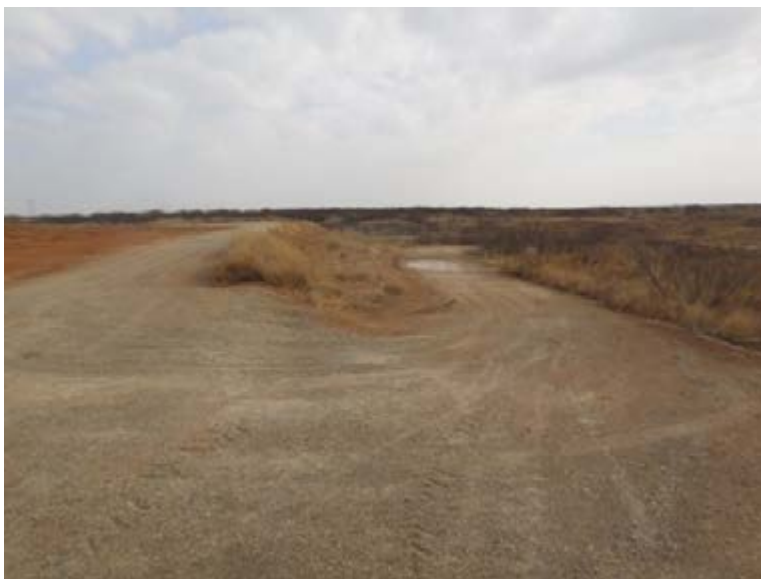
The outside slope of the abutments and groin were uniformly graded and covered with sparse grass. Erosion or uncontrolled seepage was not observed along either groin. Figure 5.2.4-1 shows the general condition of the Abutments and Groin.

Figure 5.2.4-1. Southern Groin.

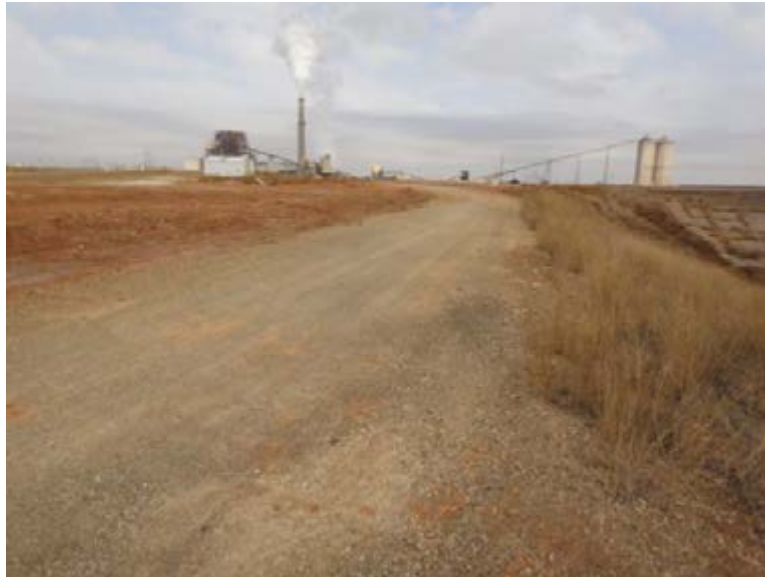
The crest of the East Embankment showed no signs of depressions, tension cracks, or other indications of settlement or shear failure, and appeared to be in satisfactory condition. Figure 5.3.1-1 shows the conditions of the crest of the East Embankment.

Figure 5.3.1-1. Figure showing the East Embankment crest and outside slope conditions.

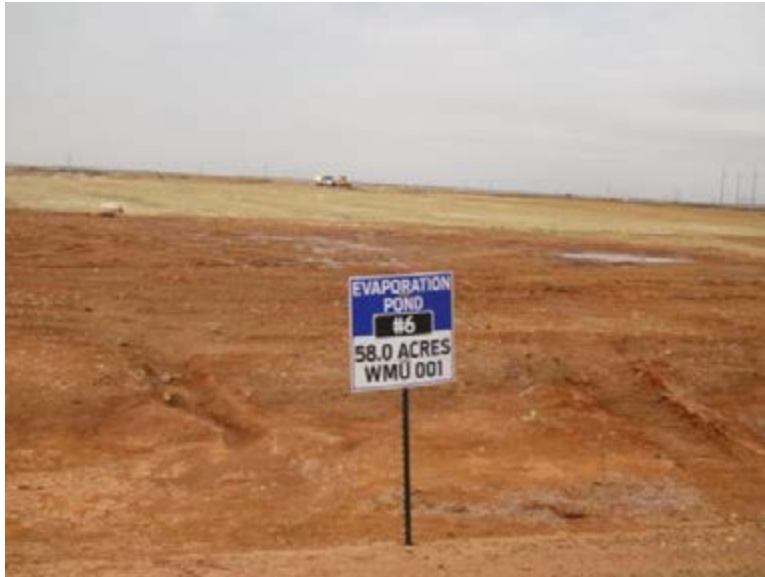
The East Embankment's inside slope is non-existent with the waste in the pond being allowed to remain in place up to near the crest elevation of the embankment. The Pond appears to be allowed to fill up with solid ash waste working its way east to west. This condition can be viewed in Figure 5.3.2-1.

Figure 5.3.2-1. East Embankment, lack of inside slope.

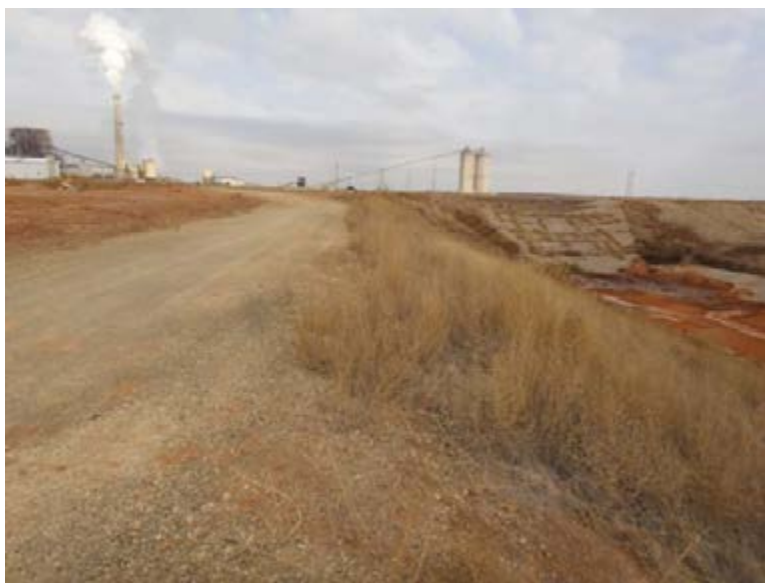
There were no observed scarps, sloughs, bulging, cracks, or depressions indicating slope instability or signs of erosion. The outside slope of the East Embankment is the upstream slope of the Emergency Spillway. It is uniformly graded and covered with sparsely overgrown grass. Figure 5.3.3-1 shows the general condition of the East Embankment's crest, outside slope and groin.

Figure 5.3.3-1. Crest, outside slope and groin of East Embankment.

There were no observed scarps, sloughs, bulging, cracks, or depressions indicating slope instability or signs of erosion on the groins of the East Embankment. The top right-side of Figure 5.3.3-1 shows the general condition of the East Embankment's groin.

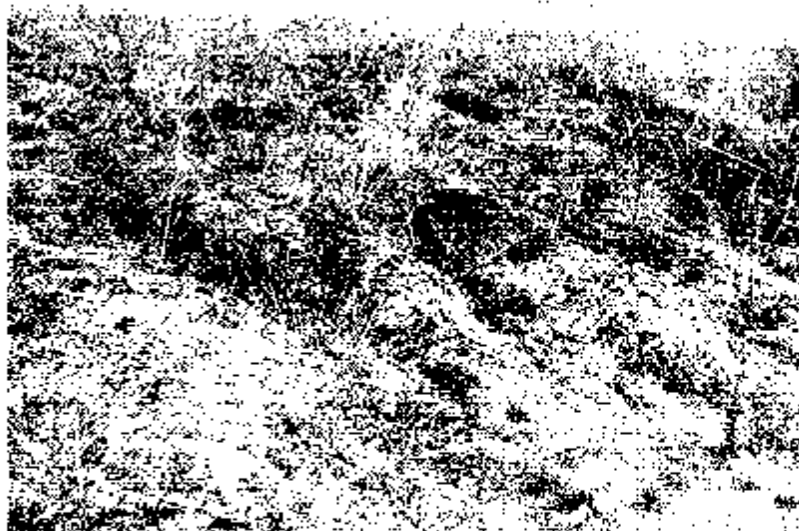
Photo # 7

Downstream side of west embankment at Wastewater Evaporation Pond #9. Notice erosion gullies.

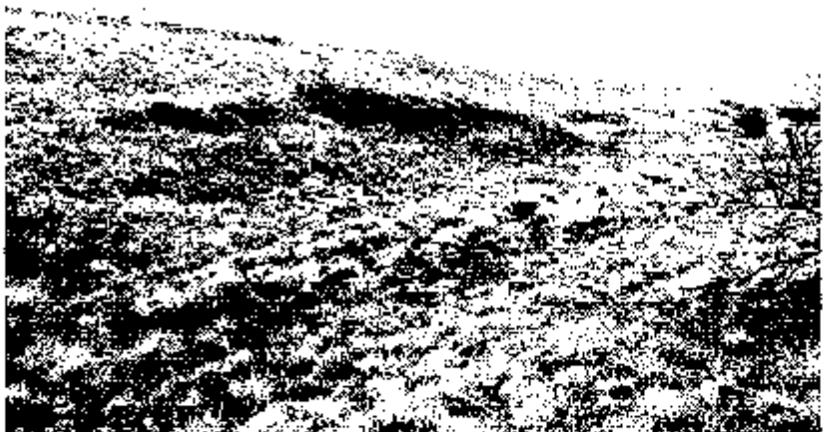
Erosion slough on west embankment at northern end of Pond #8.
